# Manhole Inspection Summary

Manhole # S69K\_\_013MH

Insp Date: 1/30/08 1:19 PM

**Location** Address: **6707 Fait Ave.**

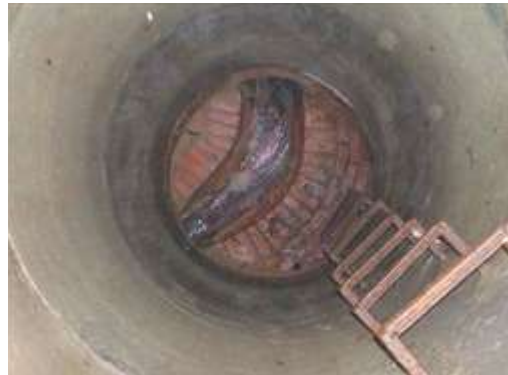
Top View

O12 top of picture

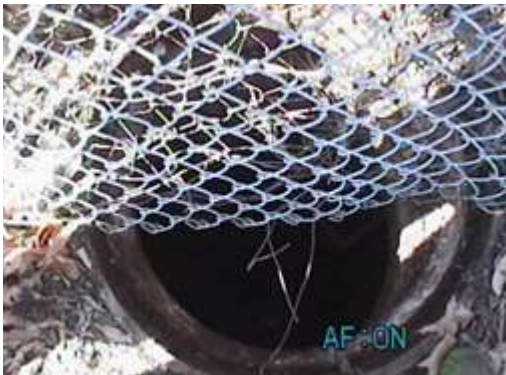
Defect 1

**Frame** Offset: **3** (in.) Condition: ☒ Sound ☐ Cracked ☐ Leaks

3 in. frame offset

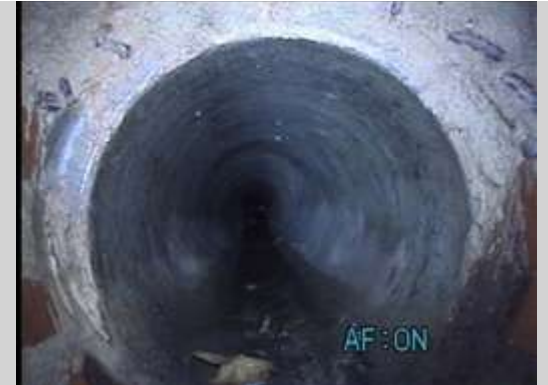
12 O'Clock Outflow

15 in. Circular Gravity Sewer  
Pipe Out @ 12 O'Clock

Pipe Height: **15.6** (in.) Rod and Bar (Angled)  
Pipe Material: **Concrete** ☐ Pipe Lined  
Invert Depth: **15.21** (ft.) Flow Characteristics: **Fast**  
Deposits: ☐ None ☐ Mud ☐ Sludge ☒ **Debris** ☐ Grease  
Silt Depth: **0.25** (in.) Deposits Extent: **Light**  
Infiltration: **None** Pipe Seal Cond: **Sound**

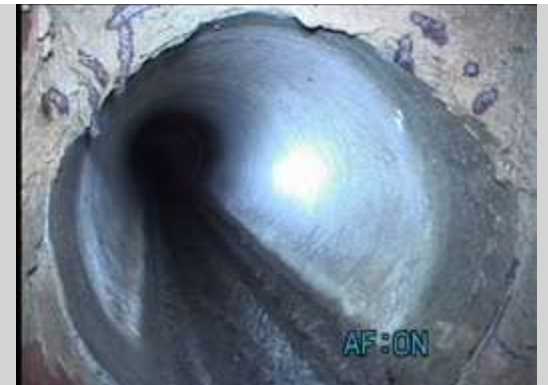
7 O'Clock Inflow

15 in. Circular Gravity Sewer  
Pipe In @ 7 O'Clock

Pipe Height: **14.4** (in.) Rod and Bar (Angled)  
Pipe Material: **Concrete** ☐ Pipe Lined  
Invert Depth: **14.63** (ft.) Flow Characteristics: **Fast**  
Deposits: ☒ **None** ☐ Mud ☐ Sludge ☐ Debris ☐ Grease  
Silt Depth: (in.) Deposits Extent:  
Infiltration: **None** Pipe Seal Cond: **Sound**
